# Evidence of Vitrified Stonework in the Inca Vestiges of Peru

By [Jan Peter de Jong](#) & [Christopher Jordan](#)

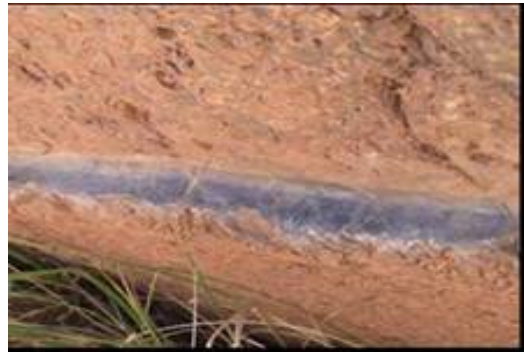
In Sacsayhuaman, there are many indications of the use of heat. Strange marks on the stones like the one on the right can be found; shiny, completely smooth and with another color to the rest of the rock.

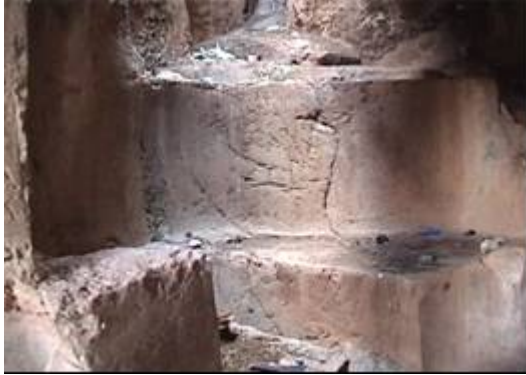
The sample is from a rock outcrop above Cuzco. Inside a cave there is an altar formed from rectangular shapes made of the rock. Several lines in the rock have a shiny surface, as if they were branded into the rock. They are on right lines on the wall of the cave. The walls are cut out with curved and rectangular forms in them. These are man made structures, which rules out natural phenomena.

In order to get a clear idea of what the make up of these intriguing layers of stone are, a sample has been tested. A small sample from the Peruvian site called Tetecaca has been collected for further analysis. This smooth layer has been analyzed by the University of Utrecht, Holland.

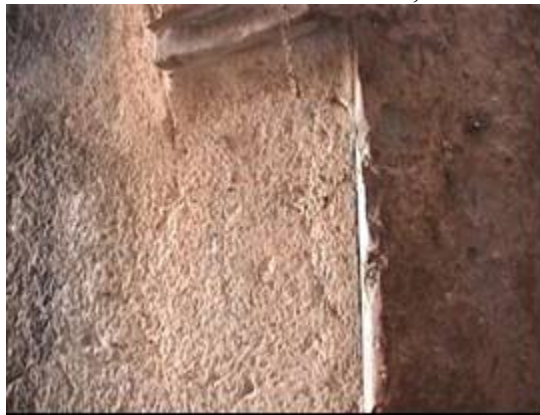
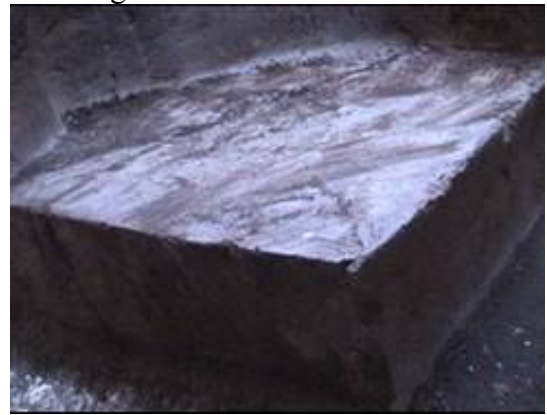
Pictures from inside of the cave, walls with long, straight reflecting lines and an altar structure:

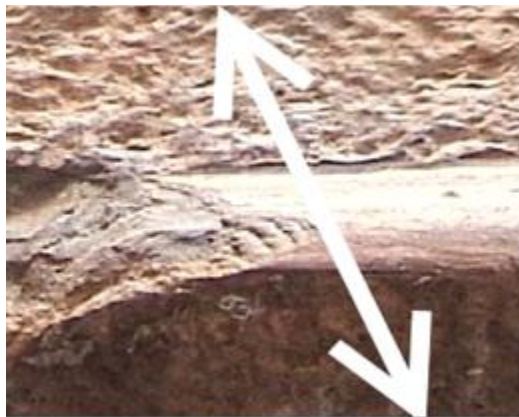
Below is a picture of the spot where the sample was found.

The white line indicates where the thin section was made. The smooth layer on the picture is about 2 cm wide and 1.3 cm deep. The sample was carefully cut into two parts and a thin section was taken for analysis in the Microprobe, jxa 8600 Pioneer. Several points were measured on the inside of the sample and on the smooth surface.
